Project #: 011L-101

March 1, 2011

A Reserve Study was conducted for Forest Brooke Residents Association to determine a reasonable level of annual reserve fund contributions required to meet the future expenditures for the elements on the property that will likely require major repairs or replacements over the next 30-year period. The elements that have been included in the Reserve Study are considered common to the property as defined by the Association's declarations and bylaws, unless otherwise noted.

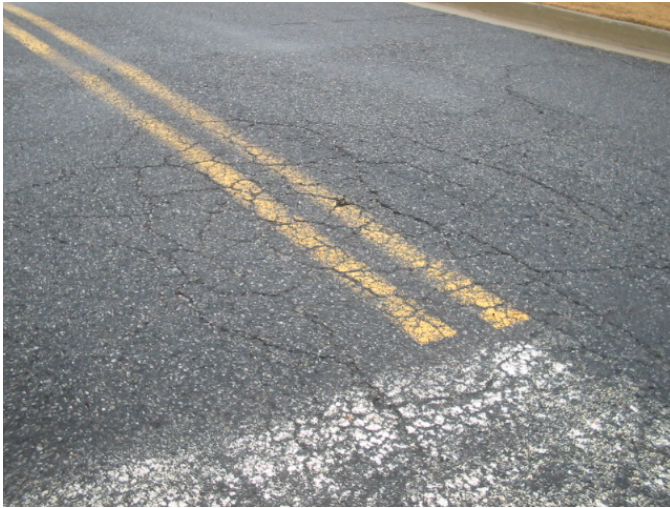
- Areas of asphalt deterioration
- Loose boards on privacy fence
- Settled areas of pool deck

Example of asphalt alligating at amenity entry

Periodic seal coating and crack sealing approximately every 5 to 6 years is the most important preventative maintenance that can be done to extend the life of asphalt pavement. Seal coating minimizes oils from evaporating, reduces the degradation that occurs from ultraviolet light, and prevents water from penetrating the pavement. Random cracks that are greater than 1/8" in width should be routed out, cleaned, and filled with a rubberized hot tar crack sealant to prevent water from penetrating the pavement. Based on the observed conditions and the estimated age and condition of the coating, we have included funding for replacement over the 30-year period of this study as illustrated in the chart below and Exhibit 2.

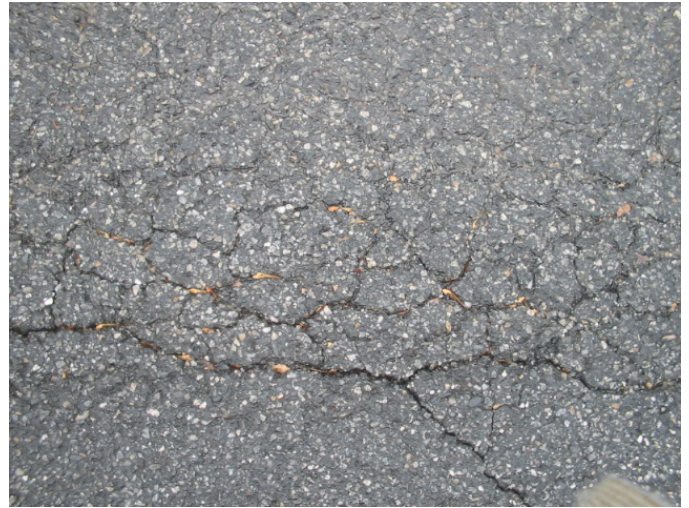
Example of asphalt alligating near poolhouse

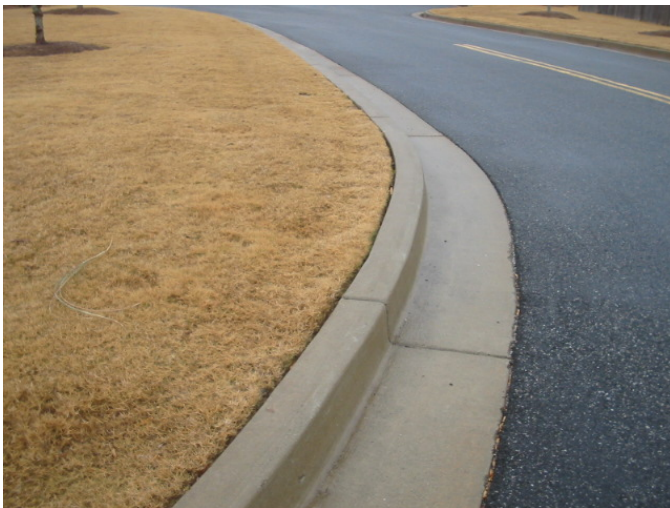
Example of concrete curbing

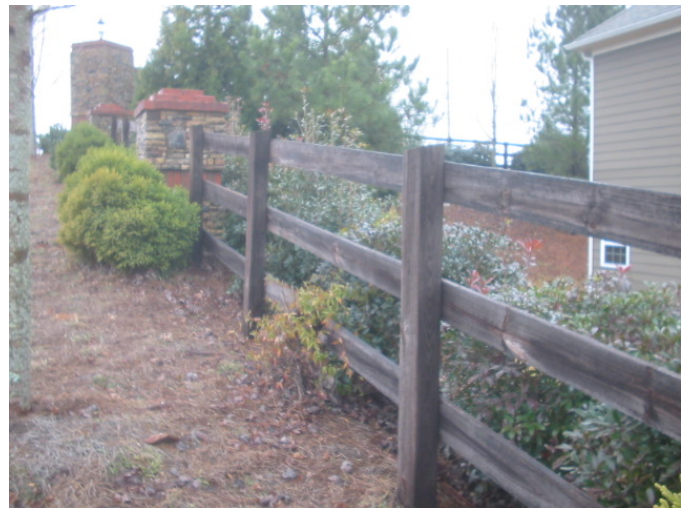
View of 3-rail fence

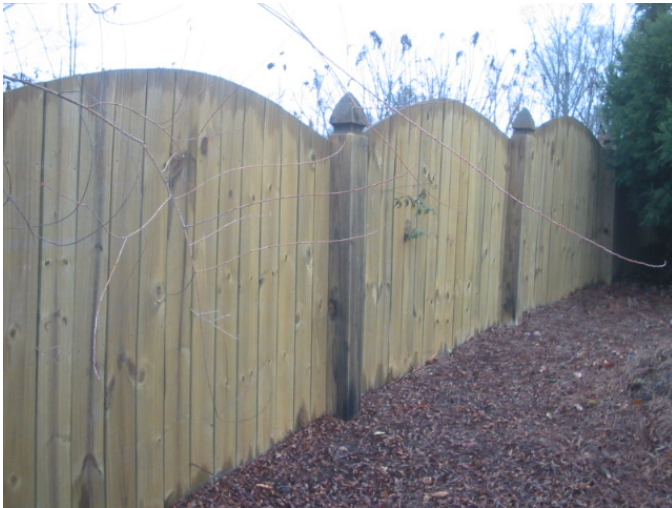
The 6' high wood privacy fencing located along Bethelview Road is original. Some loose pickets are present. At the time of the inspection, the fencing did not appear to have a protective coating applied to it. Therefore, we recommend that a protective coating be applied to it to prolong its useful life. Replacement of the wood fencing is periodically necessary due to lateral displacement of the vertical support posts, wood rot, termite damage, and mechanical damage to the pickets or rails, etc. Based on the observed conditions, funding has been allocated for wholesale replacement of the wood fencing as illustrated in the chart below and Exhibit 2. The recurring expense of applying a protective coating to the fencing is considered to be a maintenance item; therefore, adequate funding should be allocated to the operating and maintenance budget for such an expense.

View of privacy fence along Bethelview Road

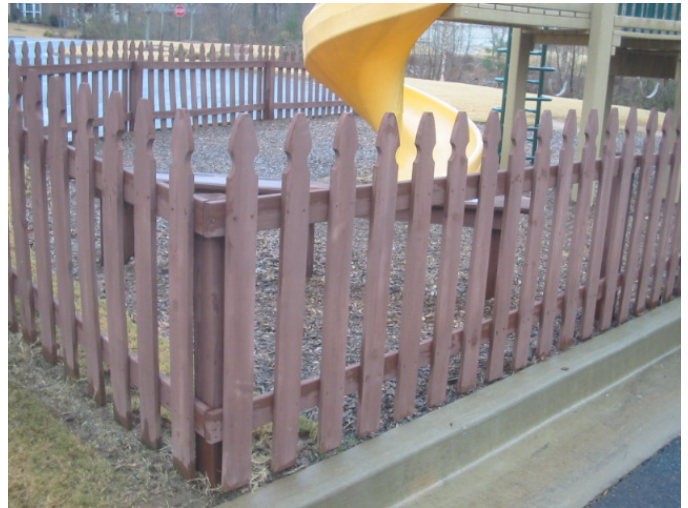
Picket fence at playground

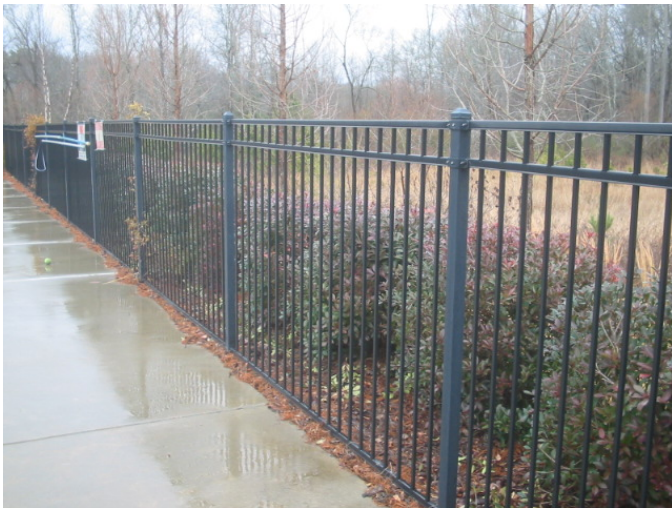
The 5' high aluminum fence around the pool perimeter should last indefinitely if properly maintained. However, minor replacements may be necessary due to damage or lack of maintenance. Based on the observed conditions, funding has been allocated for replacement of the fencing as illustrated in the chart below and Exhibit 2.

View of pool fence

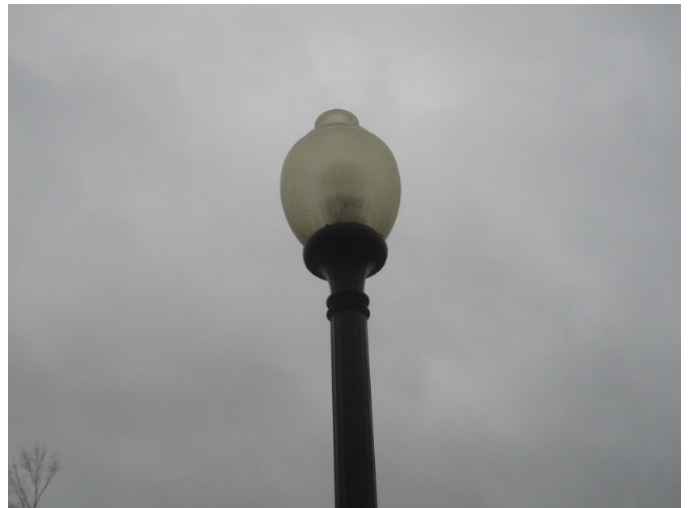
Example of parking area general lighting

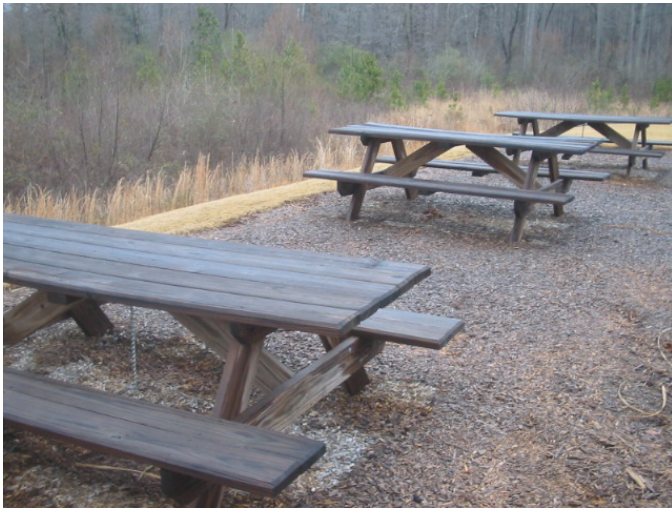
View of picnic tables behind pool area

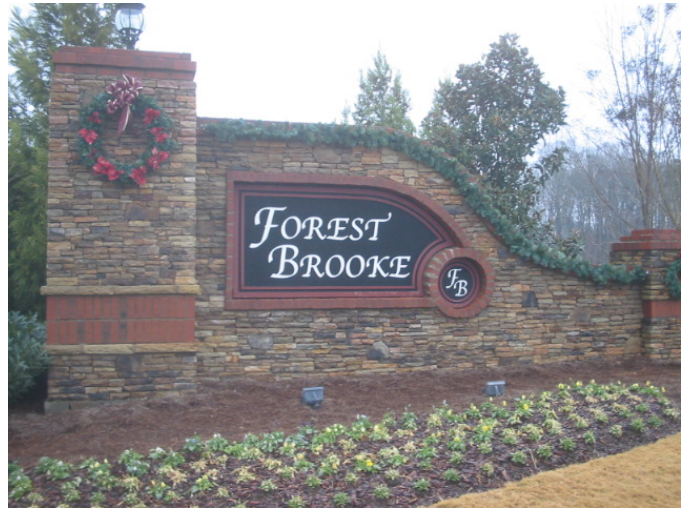
Mounted on the entrance monuments are urethane signs. At the time of the inspection, one of the signs was noted to be loose. Over time, signage of this type can become warped, damaged, or experience deterioration that necessitates replacement. Based on the observed conditions, funding has been allocated for wholesale replacement of the signage to maintain the aesthetics of the property as illustrated in the chart below and Exhibit 2.

Example of entry monument and signage (1 of 2)

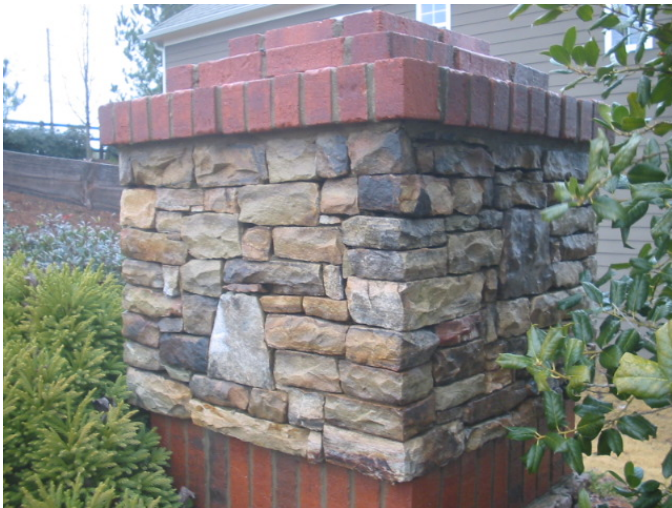
Example of fence columns

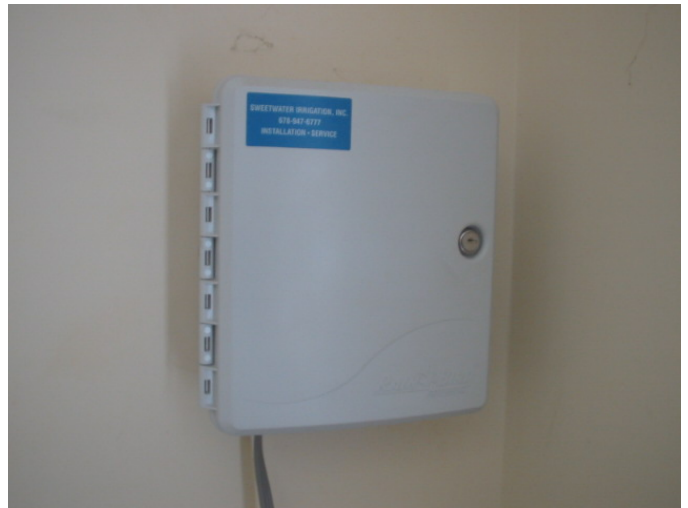
Example of irrigation control board (1 of 2)

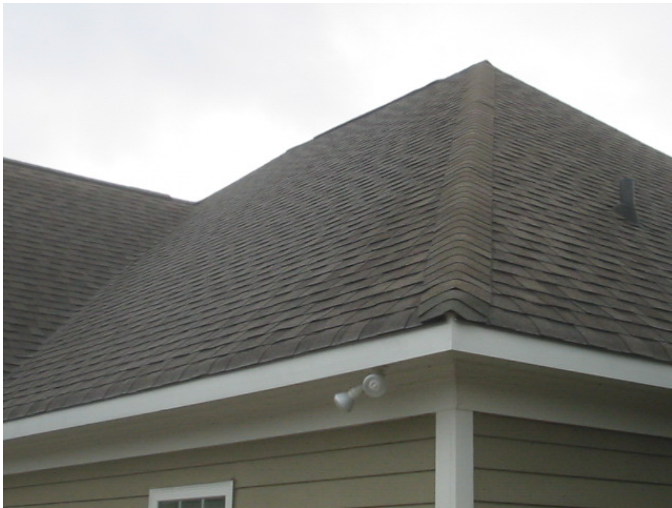
View of poolhouse shingle system and eaves

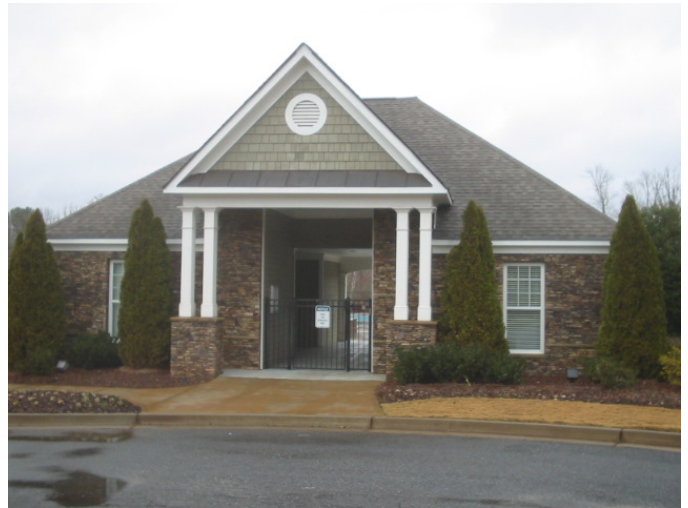
Poolhouse front elevation. Note stone veneer and shingle siding at gable, windows.

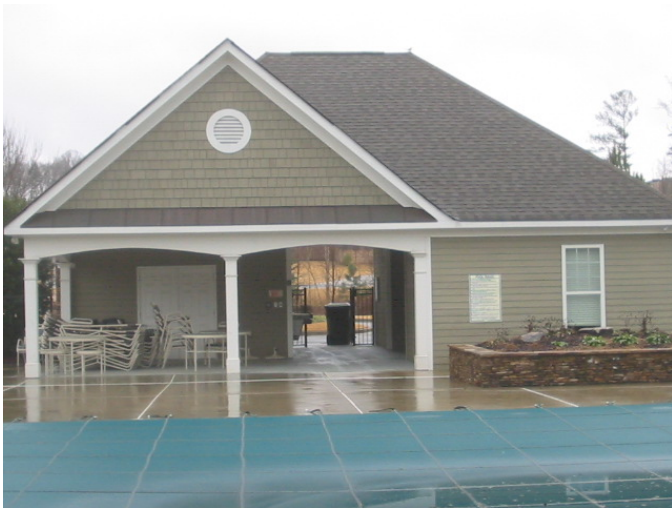
Poolhouse rear elevation. Note siding materials, metal roofing on eave return, window

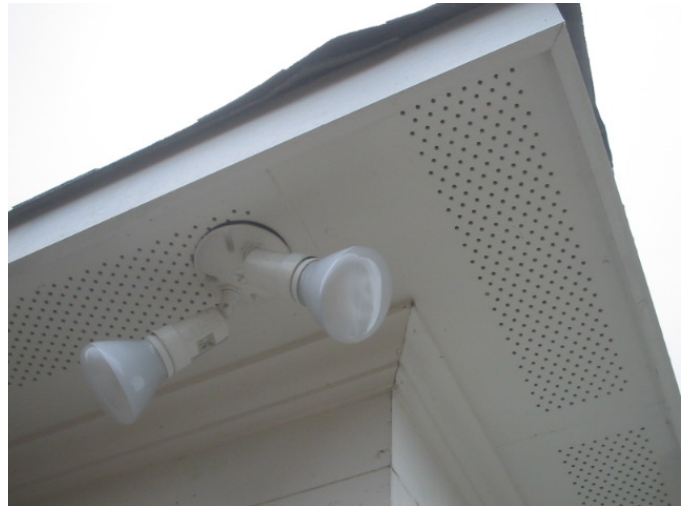
Eave detail. Note floodlight

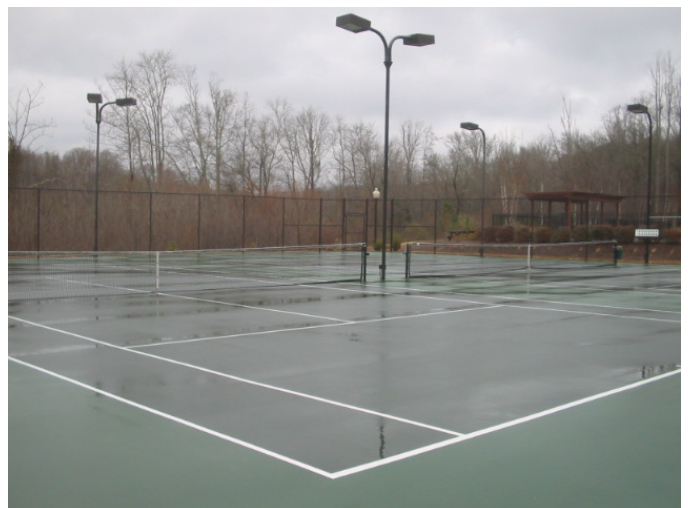
View of tennis courts. Note fence, lights
